TEL001 – Summary of the April 2006 Repair Work
19-Sep-2006
Jamie Blowers, Technical Division

This is a brief summary of the work done to repair TEL001 (pressure vessel RSB-0536) in April 2006, during the extended shutdown. We attempted to capture the hours on job # 395 (project/task 30/30.9.1.1.5.1.1). According to TDCharge we logged 340.5 hours on this job. In addition 74.5 hours were logged on Machine Shop job V8559.

This note is an attempt to document the details of the TEL #1 (TEL001) leak investigation and subsequent repair.

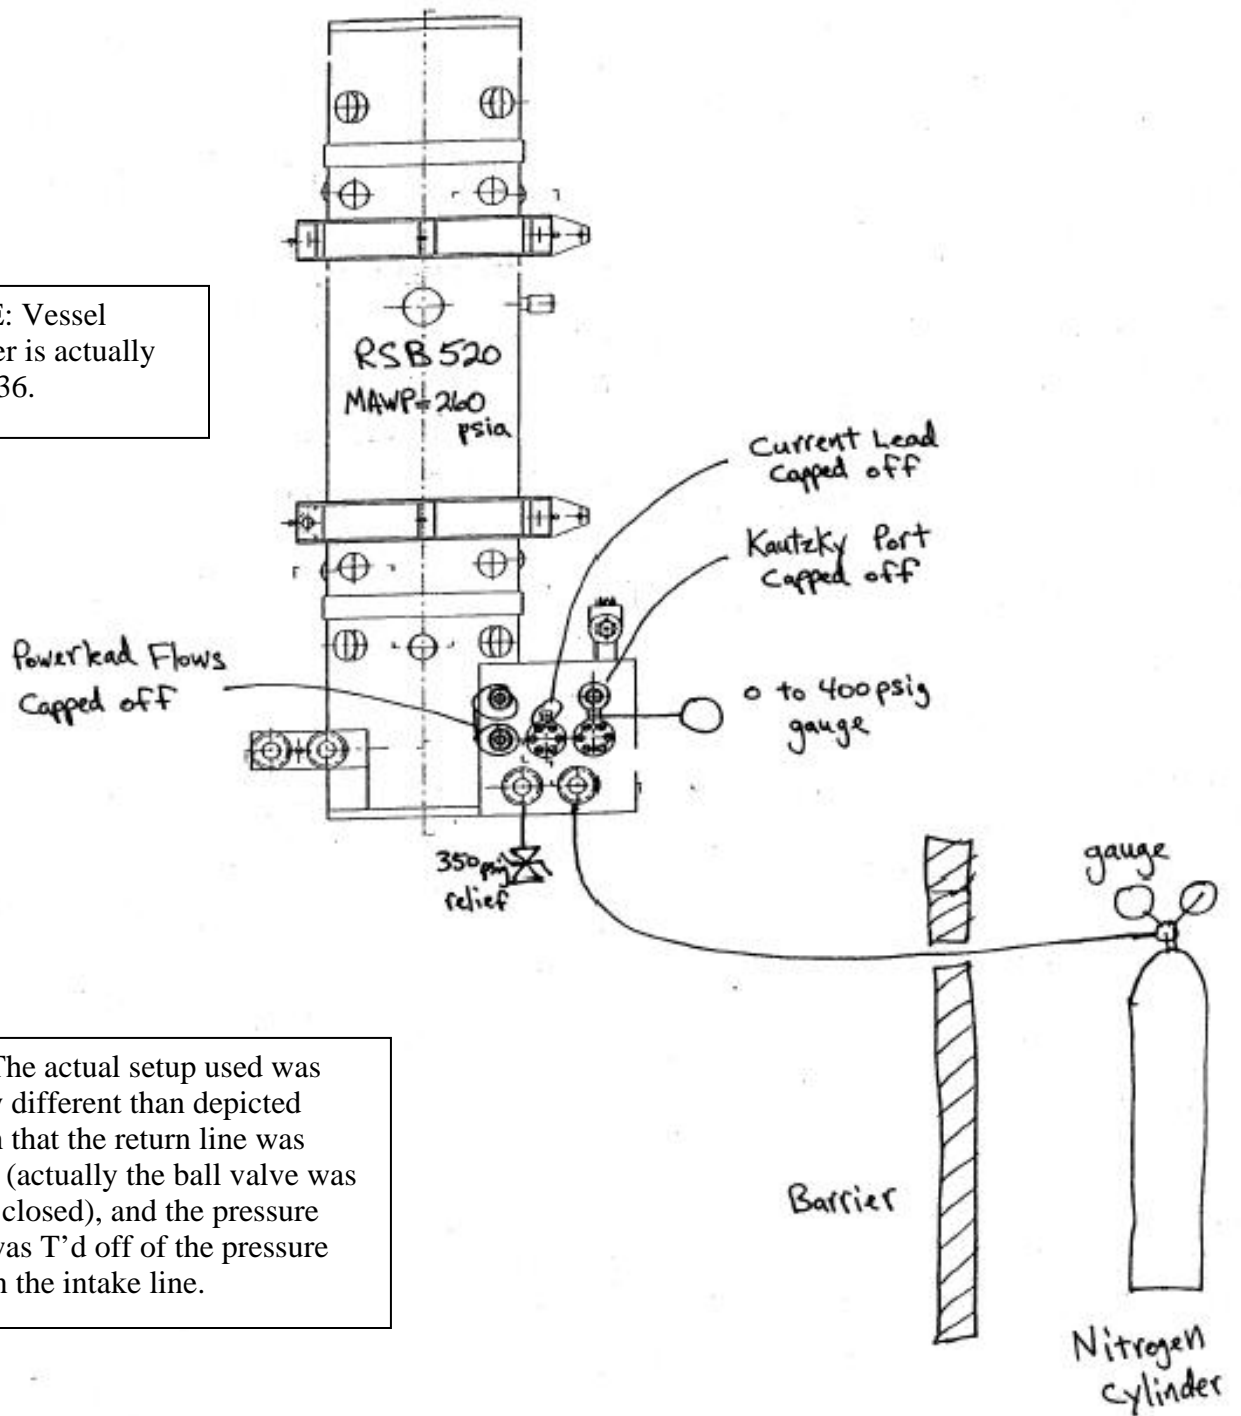
Figure 1. Schematic of TEL1 Pressure Test at IB2.

Note: The actual setup used was slightly different than depicted here, in that the return line was capped (actually the ball valve was simply closed), and the pressure relief was T'd off of the pressure gage on the intake line.
